Solutions for failing asphalt

Multi-storey
car park
decks and ramps

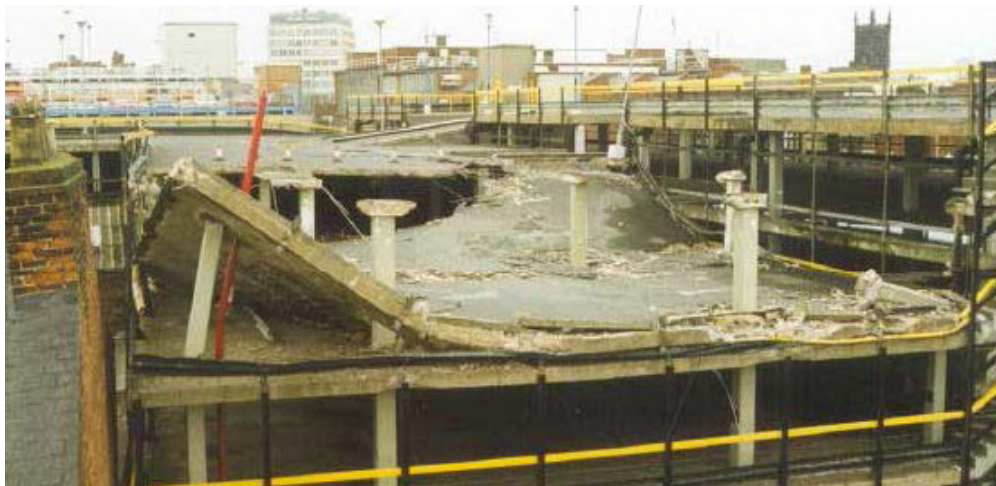
Pipers Row car park, Wolverhampton in 1997. Partial collapse attributed to carbonation and a lack of waterproofing to cracks <https://www.hse.gov.uk/research/misc/index.htm>

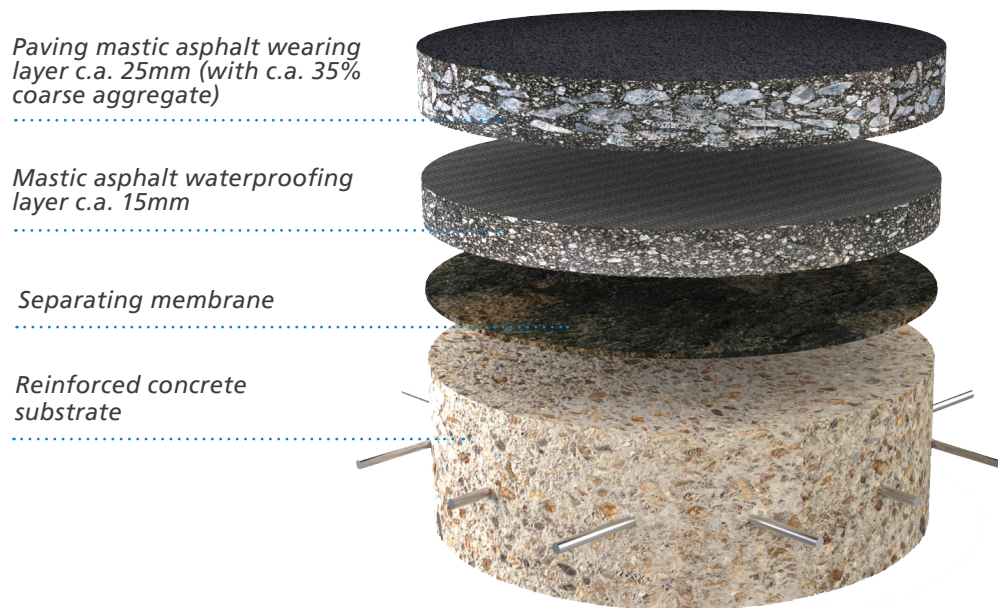
What is the asphalt used on car parks?*

*Typical thicknesses based on thousands of core samples taken from asphalted car park decks by Triflex in the UK.

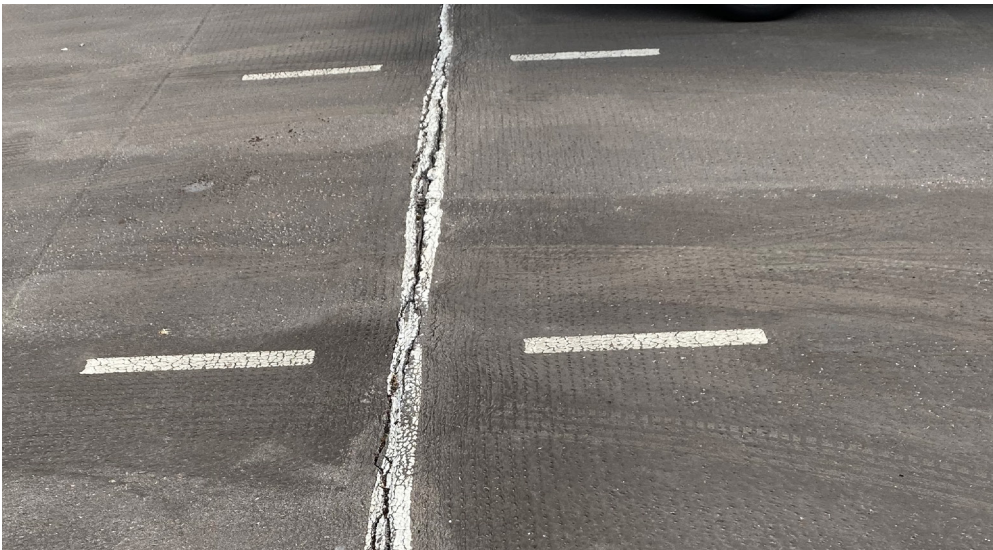
1. Asphalt cracking

Cracks in the waterproofing allow a direct path for water and chloride ingress as well as carbonation. They most commonly occur in the weaker asphalt day joints or at upstands and interface details. Large car park structures will have numerous asphalt day joints and details creating a significant number of high risk zones.

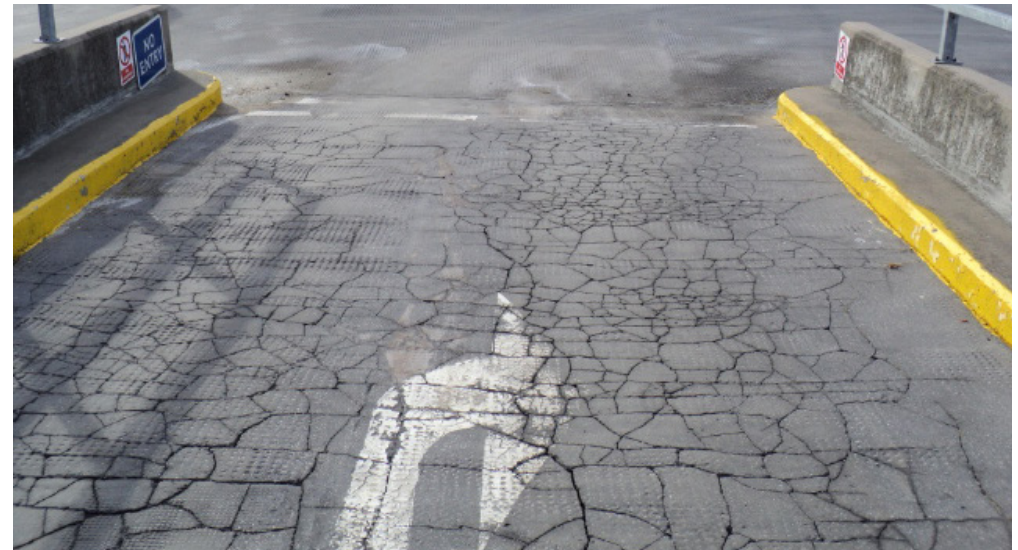
Cracks are also found in the asphalt surface, where aged asphalt has shrunk. As the flux oils and other volatiles are lost from asphalt, it becomes less flexible and shrinks due to loss of mass.

Alternatively, if the separating tissue between the asphalt and underlying concrete is damaged or missing, the asphalt may stick to the concrete. As the asphalt is designed to allow movement during temperature changes, it may tear and crack if adhered to the substrate. Similarly, cracking and movement in the underlying concrete transfers directly into the asphalt, resulting in crack formation in the asphalt.

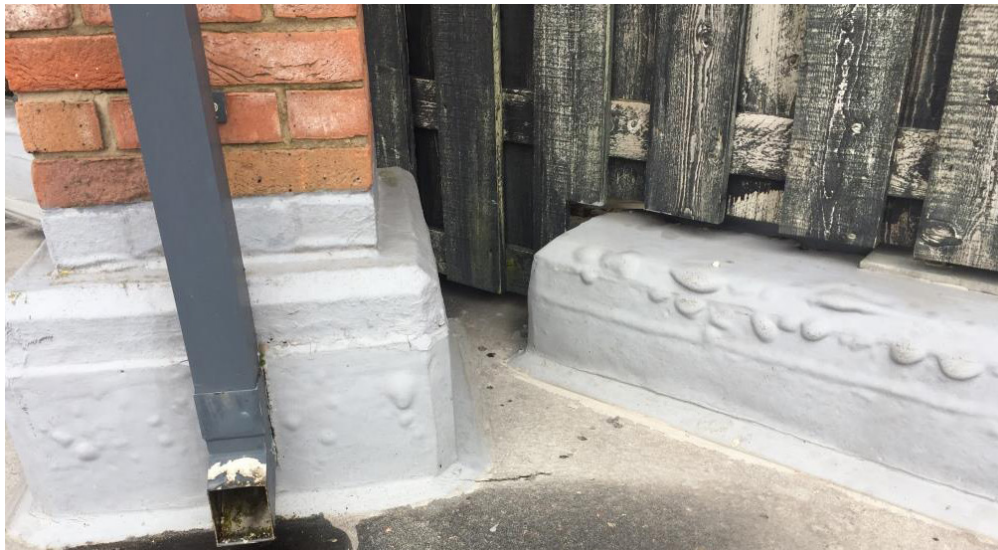
2. Asphalt details and interfaces

Roofing grade mastic asphalt is used to form interfaces with other details. All of these details whether upstands, drainage outlets, channels, posts, or plinths etc. are potential failure points for asphalt waterproofing.

These areas are vulnerable because the asphalt to the main area is de-bonded and can move freely, whereas the asphalt details are bonded. Structural movement, as well as thermal expansion and contraction will place significant stress on the asphalt at these interfaces, particularly during cold weather when the thermoplastic asphalt is most brittle.

These issues can manifest in the form of tears and cracks at the interfaces allowing a direct path for water, chlorides and carbonation.

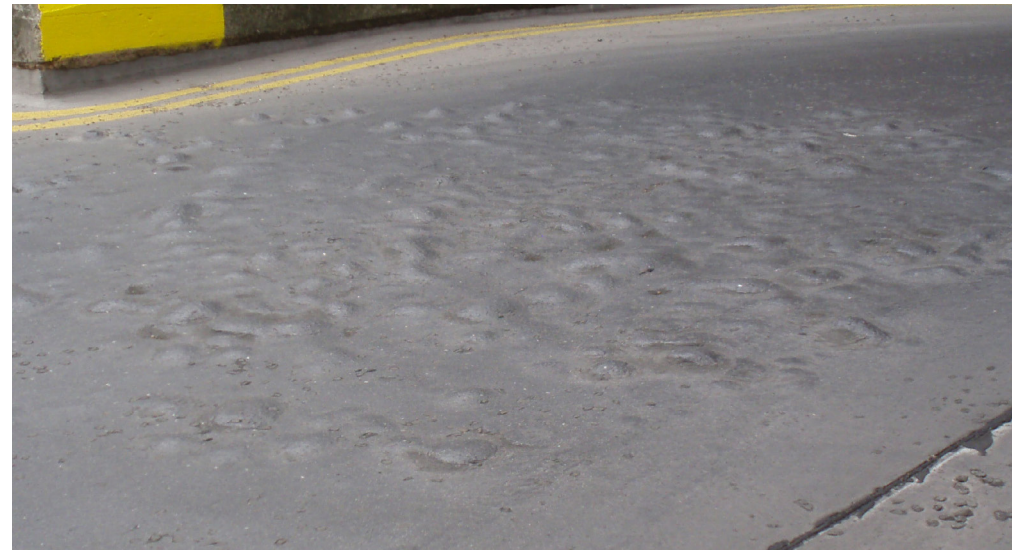
3. Blisters in asphalt

Blisters are caused by trapped moisture and air heating up to create a vapour pressure. This moisture may be in the substrate beneath the asphalt or between the asphalt layers (interstitial) in multi-layer systems found in car parks. The blistering can occur soon after installation, or in some cases, take many years to form. The blisters can also continue to expand progressively due to a cyclical pumping action.

Evident as raised or domed areas, blisters vary from a few centimetres across to a few metres or more. They can occur singularly but are commonly found in clusters, particularly on ramps where the asphalt is fully bonded. Besides being a trip hazard, blisters need repair. Left alone they may collapse and compromise the waterproofing integrity, risking structural damage.

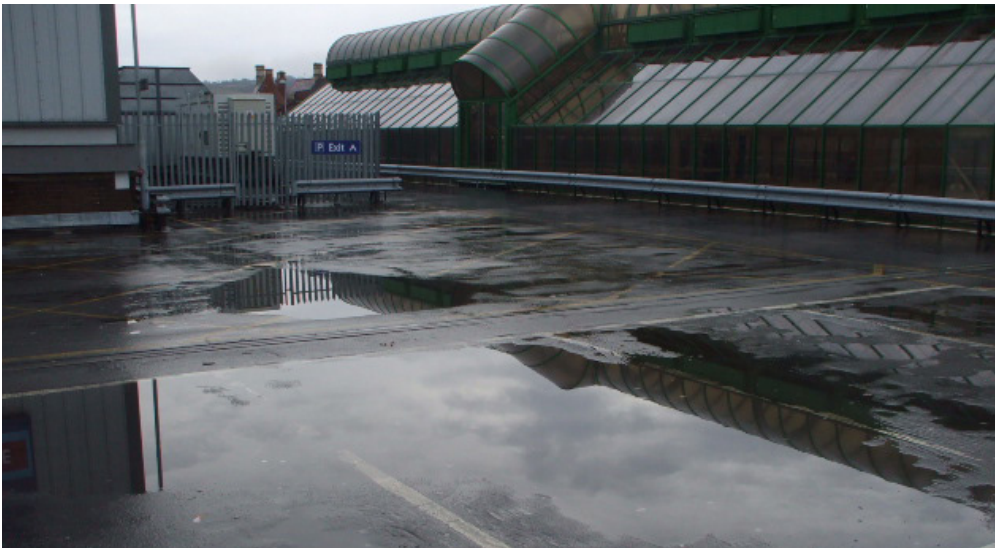
4. Surface ponding

It is recommended that falls in car park decks should be a minimum of 1:60. Unfortunately, the designed and as-built construction do not always match, and ponding is common on asphalted car parks. Causes include poor construction, deflection within the structure, insufficiently designed falls and a lack of or poorly located drainage outlets.

Mainly considered as an inconvenience, ponding water is avoided by pedestrians who want to keep their feet dry. However, frozen ponded water presents a severe health and safety slip hazard for pedestrians and in extreme circumstances, vehicles. The reason this often gets left untreated is that asphalt cannot be laid to falls to correct inherent issues, and cannot be laid on top of existing asphalt once the issue has appeared.

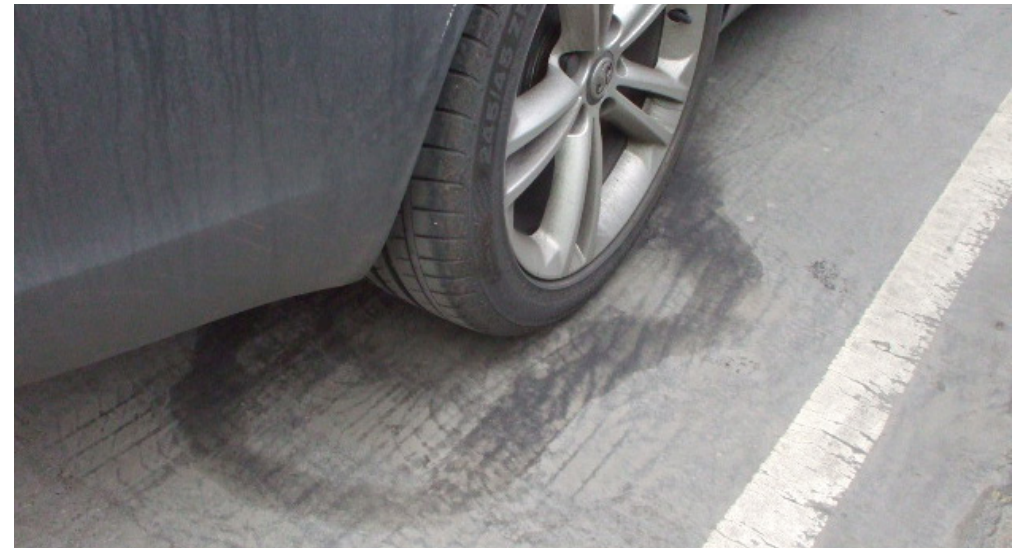
5. Tyre indentations

Where asphalt lacks enough stone content at the surface or is soft, tyre impressions or wheel indentations commonly form. As heavier electric vehicles increase in number, and temperatures rise due to climate change, the frequency of these will increase. Asphalt surfaces are softer where the ratio of bitumen-rich material to aggregate is higher. This can be due to variations in the size or amount of aggregate in the paving grade wearing layer or a paving asphalt layer which is applied too hot.

A bitumen-rich surface becomes even softer in high temperatures or when heat load dissipates from a vehicle, due to the bitumen's thermoplastic properties. Indentations are often worsened by the displacement of asphalt to the perimeter. The resulting lip can lead to localised ponding, a trip hazard or icy patches in winter, directly where vehicles are designed to stop.

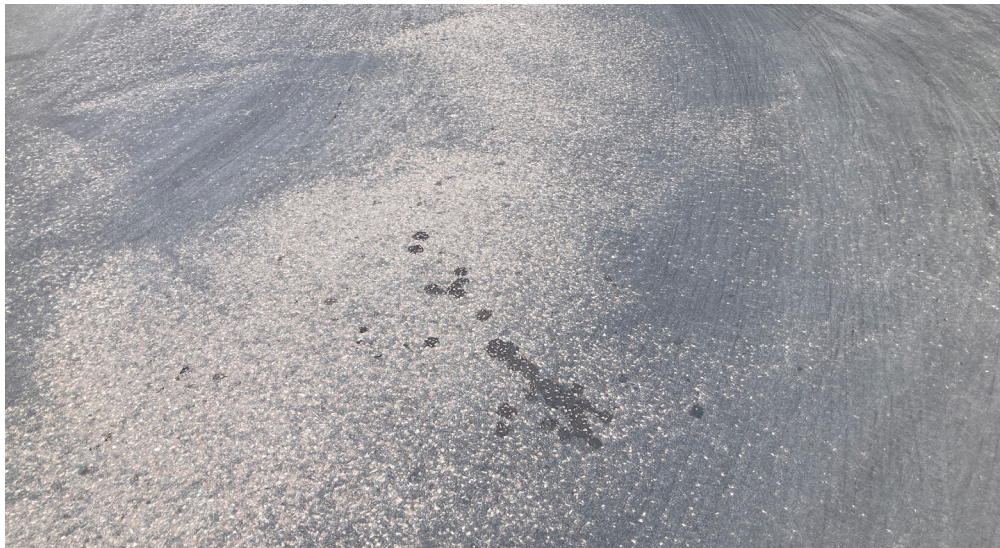
6. Skid risk from worn asphalt

As asphalt ages and is trafficked extensively, the paving asphalt can wear and polish to a hazardous state. Crimped finishes and wearing layers are worn to a flat, smooth, shiny surface that is slippery when wet.

Ramps, ramp aprons and turning areas are especially susceptible due to the heavy shear forces from vehicle tyres. With virtually no anti-skid, traction is compromised causing a significant skid risk to vehicles and a slip risk for pedestrians.

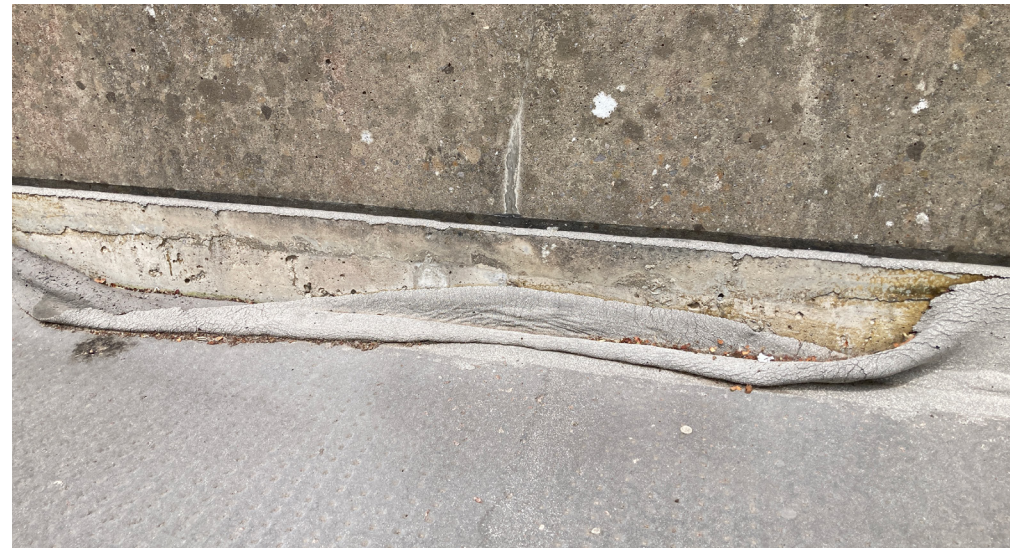
7. Slumping

High thermal loads cause thermoplastic asphalt to soften, particularly the roofing grade mastic asphalt exposed at details. South facing aspects, or surfaces where heat or sunlight is reflected from buildings are especially vulnerable. Softened asphalt becomes mobile and will slump, especially on vertical details such as upstands and stair risers.

This slumping can occur to such an extent that the asphalt falls off the detail or tears under its own weight. Both can compromise the waterproofing integrity and create a dangerous trip hazard on stairs.

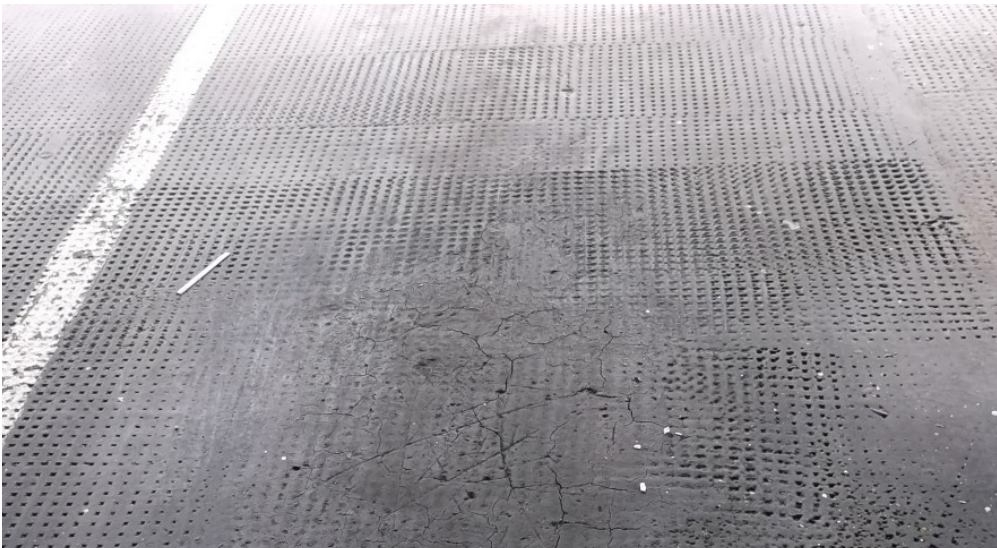
8. Asphalt contamination

Fuel, oil deposits and other contaminants can attack the bitumen-based asphalt. This causes it to lose its physical and mechanical properties leading to degradation and even break up.

The asphalt's reduced strength is prone to accelerated wear and left untreated, will prematurely fail.

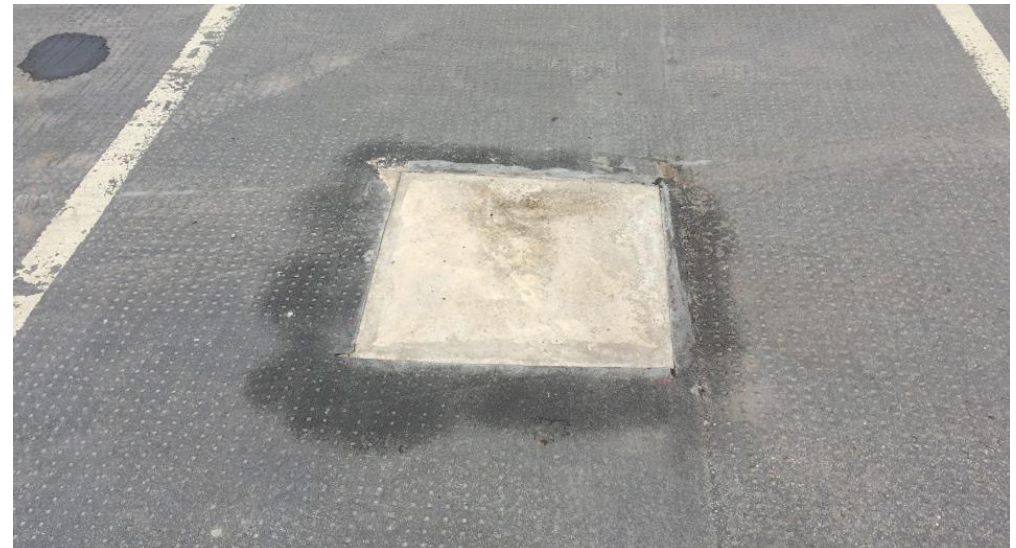
9. Asphalt repairs

Patch repairs are commonly seen in asphalt substrates and although there are complex methodologies for such repairs, these seem rarely followed. Shrinkage related failures regularly occur with cracks opening at the perimeter of the repair, allowing water ingress.

Incompatible materials such as tarmac, cold asphalt type solutions or even concrete are frequently used. These not only fail to provide a long-term solution but are not waterproof. Use of these materials allows water and chloride ingress which can cause structural issues and accelerate the failure of the original asphalt.

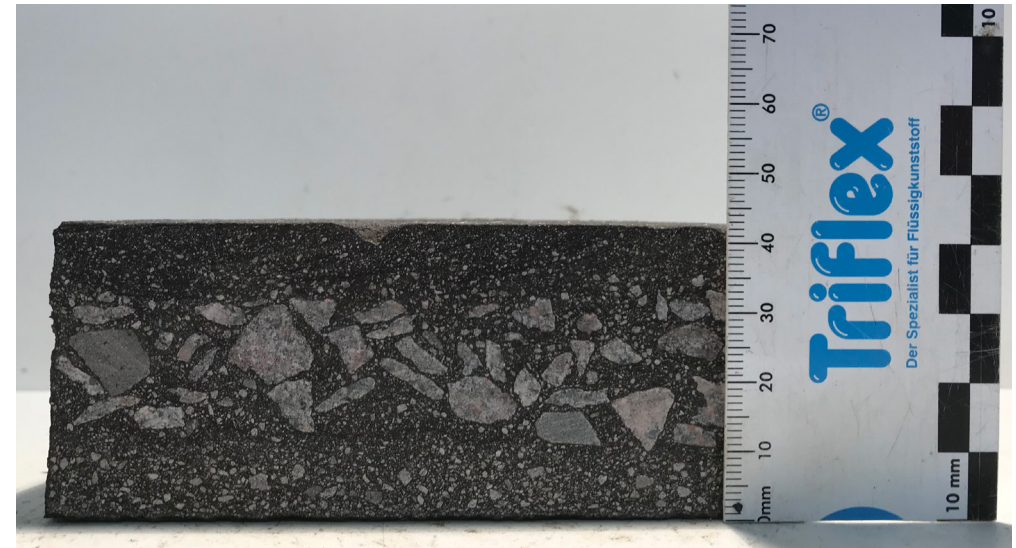
The paving asphalt layer contains coarse aggregate and should be uniform all the way to the surface. In this example, the large aggregate has sunk leaving a bitumen-rich surface. This may be due to the asphalt being too hot during installation or a lack of large aggregate. This softer, bitumen-rich surface is prone to wheel indentations, displacement, ruckling and accelerated wear.
